**Flood Control Project Maintenance
Levee Inspections****LMA District Cover Sheet****Spring 2016 Levee Inspection Results****Sutter Maintenance Yard Maintenance Area 0017**

Levee Inspection Report By Mile - Spring 2016

Waterway	Bank	Unit Miles	Inspection Start/End	Inspector
Unit No. 01 Lake County Sutter Maintenance Yard - Middle Creek	Left	3.87	05/02/2016 05/02/2016	Keith Millard

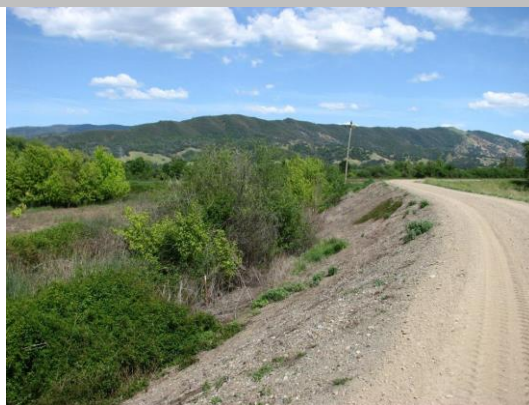
Photo 1 of 1 : SP_2016_MA0017_339_16_20160509_00028.jpg

LM Start	3.96	Rating **	M	Issue No.	16
LM End	4.03	Issue Type +	Ma	Location *	LS
Category	Earthen Levee			GPS Latitude/Longitude	
				Start	End
Item	Vegetation			39.143741 °	39.143585 °
				-122.904705 °	-122.903482 °
DWR ID	DWR_MA0017_01_s_2016_16				
Comment Code					
V2 : Remove the wild growth other than native grasses from the levee slopes.					
Inspector Comment					
Large bushes and brambles growing on wire fence on LS toe limiting visibility and access.

5/2/2016: Remove or trim dense vegetation growing on fence to allow visibility and access to L/S toe.

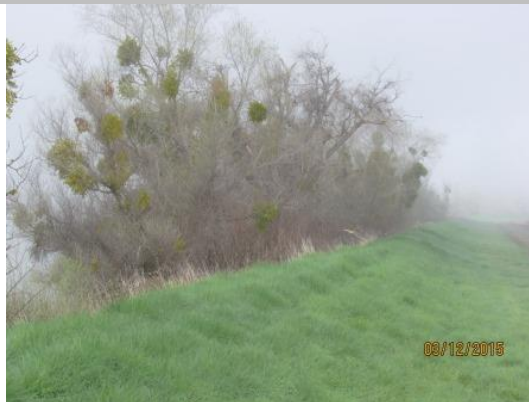
Photo 1 of 7 : SP_2016_MA0017_339_2_20160321_00001.jpg

LM Start	4.16	Rating **	U	Issue No.	2
LM End	7.23	Issue Type +	Ma	Location *	WS
Category	Earthen Levee			GPS Latitude/Longitude	
				Start	End
Item	Trim / Thin Trees			39.141894 °	39.118735 °
				-122.902201 °	-122.884892 °
DWR ID	DWR_MA0017_01_s_2012_2				
Comment Code					
T2 : Thin trees to allow visibility of the ground and room to flood fight.					
Inspector Comment					
Trees and limbs are completely obstructing visibility on crown and WS. Crown is too narrow to drive, and overgrown with weeds, brush and trees. Road follows LS toe.

View of the trees along the waterside slope and toe.

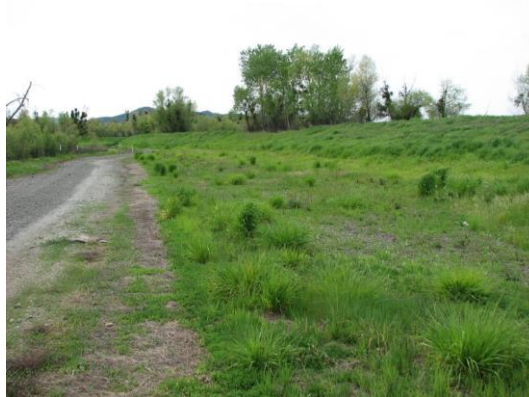
Photo 2 of 7 : SP_2016_MA0017_339_2_20160420_00022.jpg

Photo taken at LM 6.41 looking west showing overgrown LS slope of levee at right and toe road at left. Note trees obstructing visibility and access at levee crown. Crown is +/- 5 feet wide, and impassable to vehicles due to vegetation, and in some places, to pedestrians.
4/19/2016

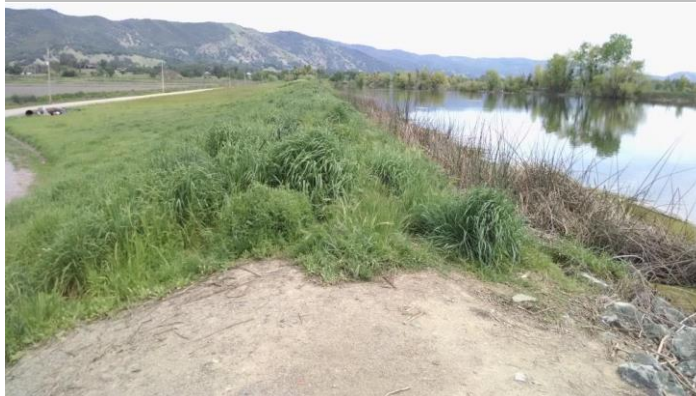
Photo 3 of 7 : SP_2016_MA0017_339_2_20160420_00024.jpg

LM Start	4.16	Rating **	U	Issue No.	2 (cont)	
LM End	7.23	Issue Type +	Ma	Location *	WS	
Category	Earthen Levee			GPS Latitude/Longitude		
				Start		End
Item	Trim / Thin Trees			39.141894 °		39.118735 °
				-122.902201 °		-122.884892 °
DWR ID	DWR_MA0017_01_s _ 2012_2					
Comment Code						
T2 : Thin trees to allow visibility of the ground and room to flood fight.						
Inspector Comment						
Trees and limbs are completely obstructing visibility on crown and WS. Crown is too narrow to drive, and overgrown with weeds, brush and trees. Road follows LS toe.

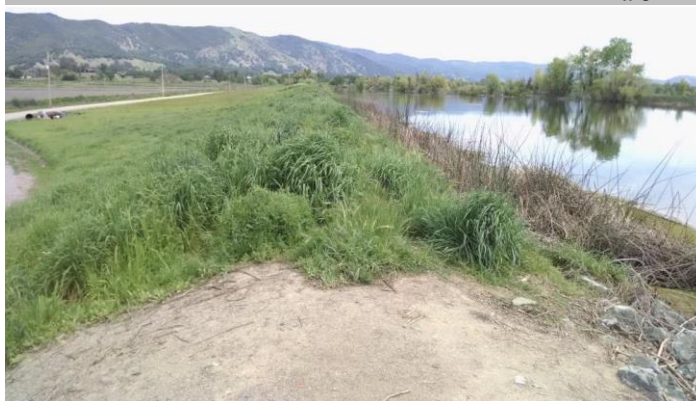
Photo 4 of 7 : SP_2016_MA0017_339_2_20160420_00026.jpg

LM Start	4.16	Rating **	U	Issue No.	2 (cont)	
LM End	7.23	Issue Type +	Ma	Location *	WS	
Category	Earthen Levee			GPS Latitude/Longitude		
				Start		End
Item	Trim / Thin Trees			39.141894 °	39.118735 °	
				-122.902201 °	-122.884892 °	
DWR ID	DWR_MA0017_01_s_2012_2					
Comment Code						
T2 : Thin trees to allow visibility of the ground and room to flood fight.						
Inspector Comment						
Trees and limbs are completely obstructing visibility on crown and WS. Crown is too narrow to drive, and overgrown with weeds, brush and trees. Road follows LS toe.

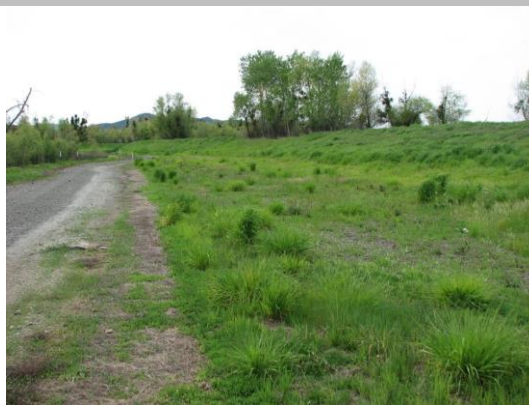
Photo 5 of 7 : SP_2016_MA0017_339_2_20160420_00023.jpg

Photo taken at LM 5.34 looking east showing narrow, overgrown, impassible condition of levee. WS is to right. 4/19/2016

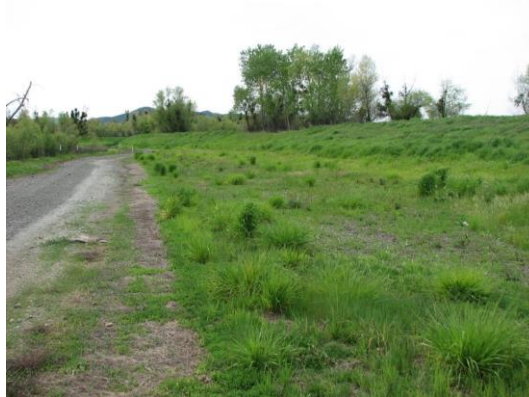
Photo 7 of 7 : SP_2016_MA0017_339_2_20160420_00025.jpg

Photo taken at LM 5.34 looking west showing narrow, overgrown, impassible condition of levee. WS is to left. 4/19/2016

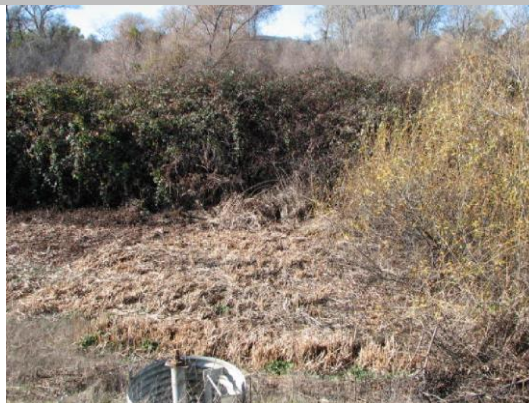
Photo 1 of 2 : UCIP_SP_2016_45783_46858.jpg

LM Start	4.27	Rating **	M	Issue No.	25
LM End	4.27	Issue Type +	En	Location *	WS
Category	Supplemental			GPS Latitude/Longitude	
				Start	End
Item	DWR UCIP Field Study			39.140422 °	39.140422 °
				-122.902022 °	-122.902022 °
DWR ID					
Comment Code					
Inspector Comment					
FS_ID:45783 DS_ID:846 EP_NO: N/A Repair Type: Non-Urgent Crossing Status: Found UCIP Comments: 4/23/2015 Still no lid on riser and wheel to operate slide gate is missing.No lid on riser-may or may not be an issue.8/2/2013 Same as last inspection.12/23/2013 Same as last inspection.7/3/2014 Same as last inspection. FIELD_STRUCT_DESC: 24-inch CMP drainpipe through the levee, 19 feet below the crown. Slide gate in 36-inch CMP riser on the waterward slope (USCE 1909). Authorized under ABO 11462, 1975. FS Date: 4/24/2015 7:33:00 AM

Slide gate in CMP riser on WS slope.

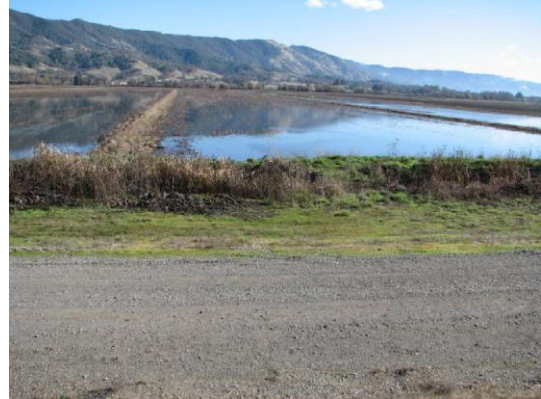
Photo 2 of 2 : UCIP_SP_2016_45783_46857.jpg

LM Start	4.27	Rating **	M	Issue No.	25 (cont)	
LM End	4.27	Issue Type +	En	Location *	WS	
Category	Supplemental			GPS Latitude/Longitude		
				Start	End	
Item	DWR UCIP Field Study			39.140422 °	39.140422 °	
				-122.902022 °	-122.902022 °	
DWR ID						
Comment Code						
Inspector Comment						
FS_ID:45783 DS_ID:846 EP_NO: N/A Repair Type: Non-Urgent Crossing Status: Found UCIP Comments: 4/23/2015 Still no lid on riser and wheel to operate slide gate is missing.No lid on riser-may or may not be an issue.8/2/2013 Same as last inspection.12/23/2013 Same as last inspection.7/3/2014 Same as last inspection. FIELD_STRUCT_DESC: 24-inch CMP drainpipe through the levee, 19 feet below the crown. Slide gate in 36-inch CMP riser on the waterward slope (USCE 1909). Authorized under ABO 11462, 1975. FS Date: 4/24/2015 7:33:00 AM

LS toe at approximate location of pipe inlet.

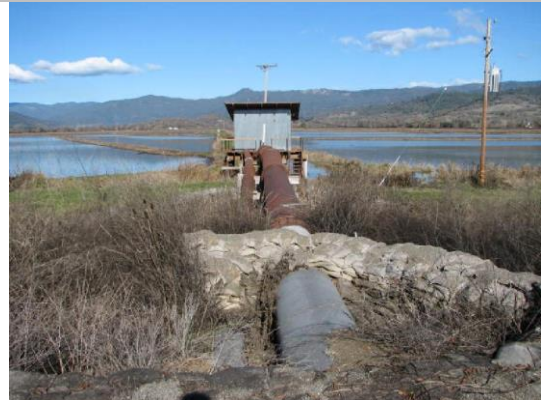
Photo 1 of 2 : UCIP_SP_2016_44730_46860.jpg

Comment Code					
Inspector Comment					
FS_ID:44730 DS_ID:847 EP_NO: 11469 Repair Type: Non-Urgent Crossing Status: Found UCIP Comments: 4/23/2015 Sack ring is still built up underneath the pipes.flood fight materials-ring levees around both LS and WS slopes at pipe crossing. This may or may not be an issue.8/2/2013 Same as last inspection.12/23/2013 Same as last inspection.7/3/2014 Same as last inspection. FIELD_STRUCT_DESC: 1 of 2: 16 inch steel drainpipe through the levee 5-feet below the crown. Drainage pumping plant on the landward side. Flap gate on the waterward end. (ABO No.11469-R.D.# 2070). This entry matches the Drainage/Irrigation Structure referenced in O&M manual (Levee Mile 5.43). Permit document and O&M referred As-built drawings are available. O&M manual Vol. 5, Revision Year 2010. FS Date: 4/24/2015 7:45:25 AM

Pumping plant, pipes, and ring levees on LS toe.

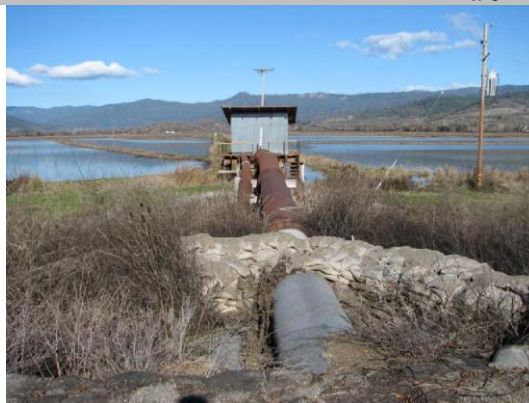
Photo 1 of 2 : UCIP_SP_2016_44729_46864.jpg

FS_ID:44729
DS_ID:853
EP_NO: 11469
Repair Type: Non-Urgent
Crossing Status: Found
UCIP Comments: 4/23/2015 Sack rings still built up underneath the pipes.flood fight materials-ring levees around both LS and WS slopes at pipe crossing. This may or may not be an issue.8/2/2013 Same as last inspection.12/23/2013 Same as last inspection.7/3/2014 Same as last inspection.
FIELD_STRUCT_DESC: 2 of 2: 36-inch steel drainpipe through the levee, 5.0 feet below the crown. Flap gate and air vent on the waterward slope. (ABO No.11469-R.D.# 2070).
This entry matches the Drainage/Irrigation Structure referenced in O&M manual (Levee Mile 5.43). Permit document and O&M referred As-built drawings are available.
O&M manual Vol. 5, Revision Year 2010.
FS Date: 4/24/2015 7:40:33 AM

Pipes and pump house on LS toe with ring levees.

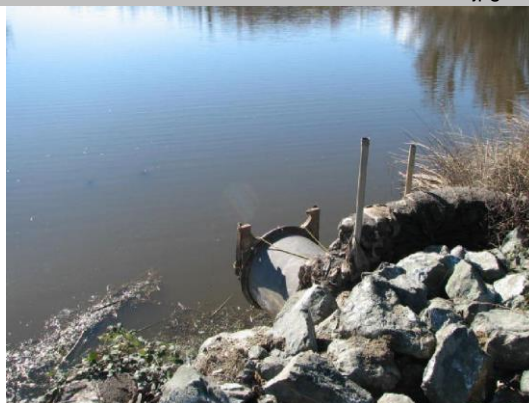
Photo 2 of 2 : UCIP_SP_2016_44729_46863.jpg

Pipe, flap gate, air vent, and sandbags on WS slope.

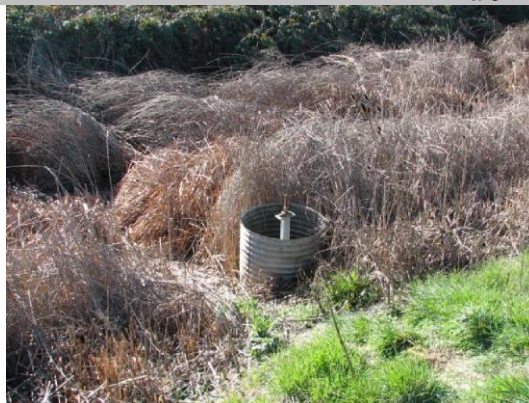
Photo 1 of 2 : UCIP_SP_2016_44731_46866.jpg

Comment Code					
Inspector Comment					
FS_ID:44731 DS_ID:848 EP_NO: 11457 Repair Type: Non-Urgent Crossing Status: Found UCIP Comments: 4/23/2015 No cover on riser and no wheel to operate gate.No cover on CMP riser and no handle for actuating gate. This may or may not be an issue.8/2/2013 Handle to operate gate was in place but still no cover on riser.12/23/2013 Same as last inspection.7/3/2014 Same as last inspection. FIELD_STRUCT_DESC: 24-inch drainpipe under patrol road and through the levee, 13.5 feet below the crown. Concrete "U" shaped headwall on the landward end. Slide gate in 36-inch CMP riser on the waterward slope. Riser unit is mounted on concrete base. (ABO No.11457-Crawford). O&M manual Vol. 5, Revision Year 2010 FS Date: 4/24/2015 7:55:38 AM

36-inch CMP riser and slide gate on WS slope.

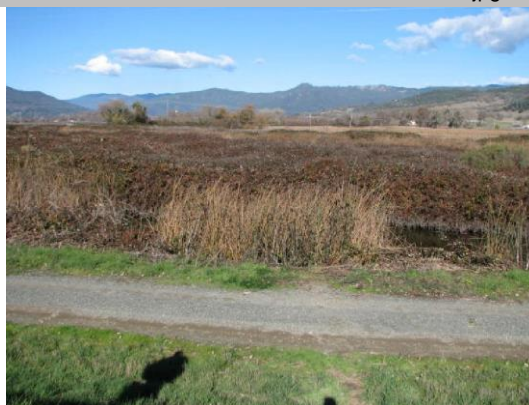
Photo 2 of 2 : UCIP_SP_2016_44731_46865.jpg

Approximate location of inlet on LS toe (not visible).

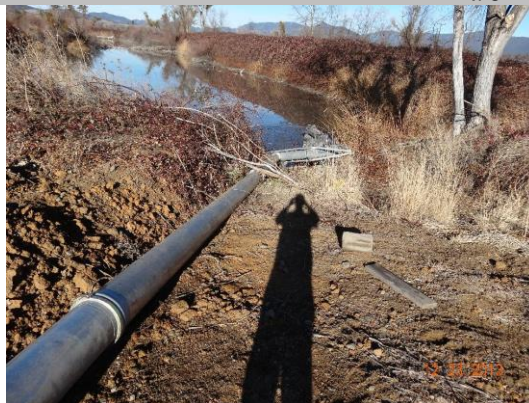
Photo 1 of 1 : UCIP_SP_2016_44735_47920.jpg

LM Start	5.99	Rating **	M	Issue No.	20
LM End	5.99	Issue Type +	En	Location *	WS
Category	Supplemental			GPS Latitude/Longitude	
				Start	End
Item	DWR UCIP Field Study			39.126057 °	39.126057 °
				-122.883096 °	-122.883096 °
DWR ID					
Comment Code					
Inspector Comment					
FS_ID:44735 DS_ID:20589 EP_NO: N/A Repair Type: Non-Urgent Crossing Status: Found UCIP Comments: 4/23/2015 12" pipe still ran over the top of roadway. No permit for crossing.8/2/2013 Same as last inspection.12/23/2013 No signs of 12" pvc. Portable tow-pump was lowered down on waterside with 12" pipe ran over roadway.7/3/2014 Same as last inspection. FIELD_STRUCT_DESC: 12-inch HDPE storm drain pipe through the crown of the levee 1.5-feet below the crown. FS Date: 4/24/2015 8:19:23 AM

Portable pump on WS and temporary piping over roadway

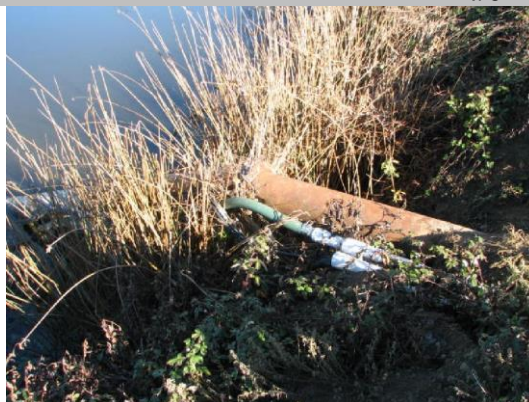
Photo 1 of 2 : UCIP_SP_2016_44736_46878.jpg

LM Start	6.00	Rating **	U	Issue No.	21
LM End	6.00	Issue Type +	En	Location *	WS
Category	Supplemental			GPS Latitude/Longitude	
				Start	End
Item	DWR UCIP Field Study			39.126038 °	39.126038 °
				-122.883351 °	-122.883351 °
DWR ID					
Comment Code					
Inspector Comment					
FS_ID:44736 DS_ID:20587 EP_NO: N/A Repair Type: Urgent Crossing Status: Found UCIP Comments: 4/23/2015 Erosion on WS shoulder is still present.No permit for this crossing. This is a primer line, used to fill up main pipe before its pump is turned on (Permit No. 11467).8/2/2013 Erosion on WS shoulder above pipes.12/23/2013 Same as last inspection.7/3/2014 Same as last inspection. FIELD_STRUCT_DESC: 4-inch PVC conduit through the levee 2-feet below the crown with plastic pipe running through it to pump on LS. FS Date: 4/24/2015 8:23:35 AM

4-inch pvc pipe with green flexible pipe running through it on WS shoulder.

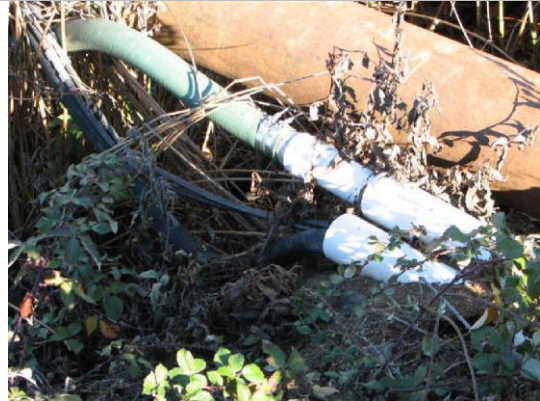
Photo 2 of 2 : UCIP_SP_2016_44736_46877.jpg

LM Start	6.00	Rating **	U	Issue No.	21 (cont)
LM End	6.00	Issue Type +	En	Location *	WS
Category	Supplemental			GPS Latitude/Longitude	
				Start	End
Item	DWR UCIP Field Study			39.126038 °	39.126038 °
				-122.883351 °	-122.883351 °
DWR ID					
Comment Code					
Inspector Comment					
FS_ID:44736 DS_ID:20587 EP_NO: N/A Repair Type: Urgent Crossing Status: Found UCIP Comments: 4/23/2015 Erosion on WS shoulder is still present.No permit for this crossing. This is a primer line, used to fill up main pipe before its pump is turned on (Permit No. 11467).8/2/2013 Erosion on WS shoulder above pipes.12/23/2013 Same as last inspection.7/3/2014 Same as last inspection. FIELD_STRUCT_DESC: 4-inch PVC conduit through the levee 2-feet below the crown with plastic pipe running through it to pump on LS. FS Date: 4/24/2015 8:23:35 AM

4-inch pvc pipe with green flexible pipe running through it on WS shoulder.

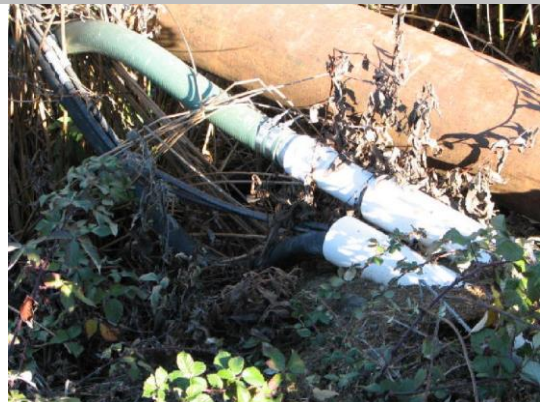
Photo 1 of 2 : UCIP_SP_2016_44737_46874.jpg

LM Start	6.00	Rating **	U	Issue No.	22
LM End	6.00	Issue Type +	En	Location *	WS
Category	Supplemental			GPS Latitude/Longitude	
				Start	End
Item	DWR UCIP Field Study			39.126038 °	39.126038 °
				-122.883351 °	-122.883351 °
DWR ID					
Comment Code					
Inspector Comment					
FS_ID:44737 DS_ID:20588 EP_NO: N/A Repair Type: Urgent Crossing Status: Found UCIP Comments: 4/23/2015 Erosion still present on WS shoulder.No permit for this crossing. It is unclear what these hydraulic lines are for, but it is probably the works for a hydraulic butterfly valve at the outlet.8/2/2013 Erosion on WS shoulder above pipes.12/23/2013 Same as last inspection.7/3/2014 Same as last inspection. FIELD_STRUCT_DESC: 4-inch PVC conduit through the levee 2-feet below the crown with hydraulic lines running through it to pump on LS shoulder. FS Date: 4/24/2015 8:28:45 AM

Pipe and hydraulic lines on WS shoulder.

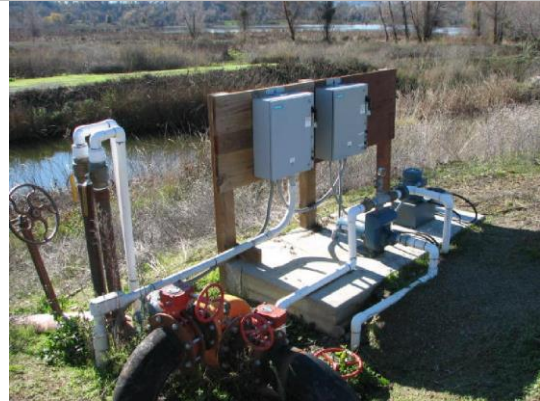
Photo 2 of 2 : UCIP_SP_2016_44737_46873.jpg

Comment Code					
Inspector Comment					
FS_ID:44737					
DS_ID:20588					
EP_NO: N/A					
Repair Type: Urgent					
Crossing Status: Found					
UCIP Comments: 4/23/2015 Erosion still present on WS shoulder.No permit for this crossing. It is unclear what these hydraulic lines are for, but it is probably the works for a hydraulic butterfly valve at the outlet.8/2/2013 Erosion on WS shoulder above pipes.12/23/2013 Same as last inspection.7/3/2014 Same as last inspection.					
FIELD_STRUCT_DESC: 4-inch PVC conduit through the levee 2-feet below the crown with hydraulic lines running through it to pump on LS shoulder.					
FS Date: 4/24/2015 8:28:45 AM

Pump station on LS shoulder, see hydraulic pump at right.

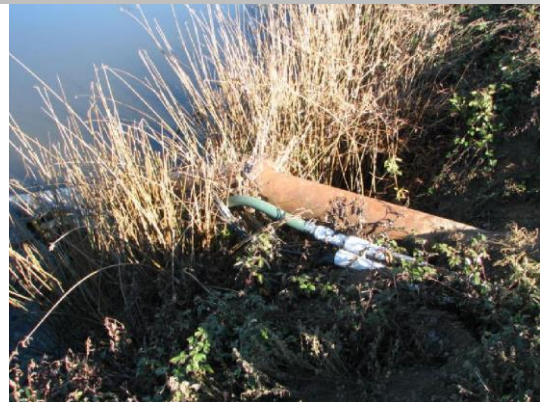
Photo 1 of 2 : UCIP_SP_2016_44738_46882.jpg

Comment Code					
Inspector Comment					
FS_ID:44738 DS_ID:850 EP_NO: 11467 Repair Type: Non-Urgent Crossing Status: Found UCIP Comments: 4/23/2015 Same as last inspection.This pipe and appurtances do not match what was described in the permit (PN: 11467). Does not appear to be in compliance with board regulations.8/2/2013 Same as last inspection.12/23/2013 Same as last inspection.7/3/2014 Same as last inspection. FIELD_STRUCT_DESC: 12-inch drainpipe through the levee, 2-feet below the crown. Butterfly Valve on the landward shoulder. Pump and electric panel along with multiple valves and appurtances on LS shoulder. (ABO No.11467-Modglin)O&M manual Vol. 5, Revision Year 2010. FS Date: 4/24/2015 8:33:13 AM

12-inch pipe and appurtenances on WS shoulder.

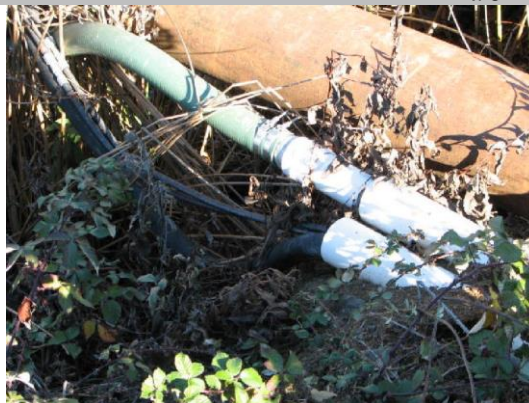
Photo 2 of 2 : UCIP_SP_2016_44738_46881.jpg

Comment Code					
Inspector Comment					
FS_ID:44738 DS_ID:850 EP_NO: 11467 Repair Type: Non-Urgent Crossing Status: Found UCIP Comments: 4/23/2015 Same as last inspection.This pipe and appurtances do not match what was described in the permit (PN: 11467). Does not appear to be in compliance with board regulations.8/2/2013 Same as last inspection.12/23/2013 Same as last inspection.7/3/2014 Same as last inspection. FIELD_STRUCT_DESC: 12-inch drainpipe through the levee, 2-feet below the crown. Butterfly Valve on the landward shoulder. Pump and electric panel along with multiple valves and appurtances on LS shoulder. (ABO No.11467-Modglin)O&M manual Vol. 5, Revision Year 2010. FS Date: 4/24/2015 8:33:13 AM

12-inch pipe and appurtenances on WS shoulder.

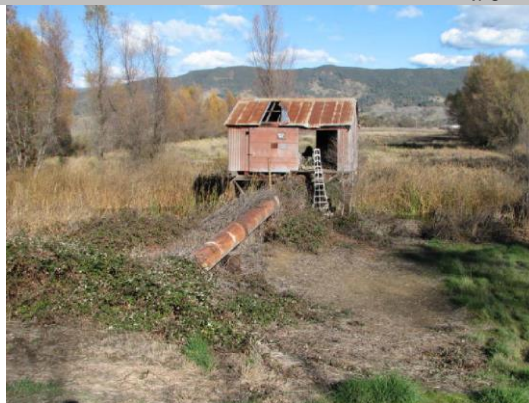
Photo 1 of 2 : UCIP_SP_2016_44739_46884.jpg

FS_ID:44739
DS_ID:851
EP_NO: 11467
Repair Type: Non-Urgent
Crossing Status: Found
UCIP Comments: 4/23/2015 Same as last inspection. Pipe still needs to be properly abandoned. Pipe should be properly abandoned. 8/2/2013 Same as last inspection. 12/23/2013 Same as last inspection. 7/3/2014 Same as last inspection.
FIELD_STRUCT_DESC: 1 of 2: *Abandoned* 16-inch Steel drainpipe through the levee 8-feet below the crown. Drainage pumping plant on the landward side. Flap gate on the waterward end. Steel plate welded on end of pipe at LS toe. (ABO No. 11467- Modglin). This entry matches the Drainage/Irrigation Structure referenced in O&M manual (Levee Mile 7.19). Permit document and O&M referred As-built drawings are available.
O&M manual Vol. 5, Revision Year 2010
FS Date: 4/24/2015 8:36:48 AM

Pumping plant in shed on LS at drainage ditch.

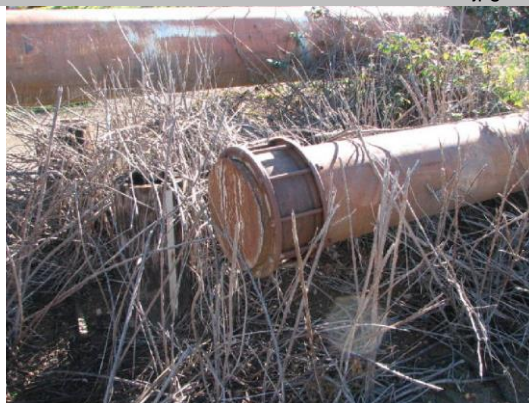
Photo 2 of 2 : UCIP_SP_2016_44739_46883.jpg

Steel plate welded over end of pipe at LS toe.
